NASA Contractor Report 165497

MICROSTRUCTURAL EFFECTS ON THE ROOM AND
ELEVATED TEMPERATURE LOW CYCLE FATIGUE
BEHAVIOR OF WASPALOY

Bradley A. Lerch
University of Cincinnati
Cincinnati, Ohio

Prepared for
NATIONAL AERONAUTICS AND SPACE ADMINISTRATION
Lewis Research Center
Under Grant NSG 3-263

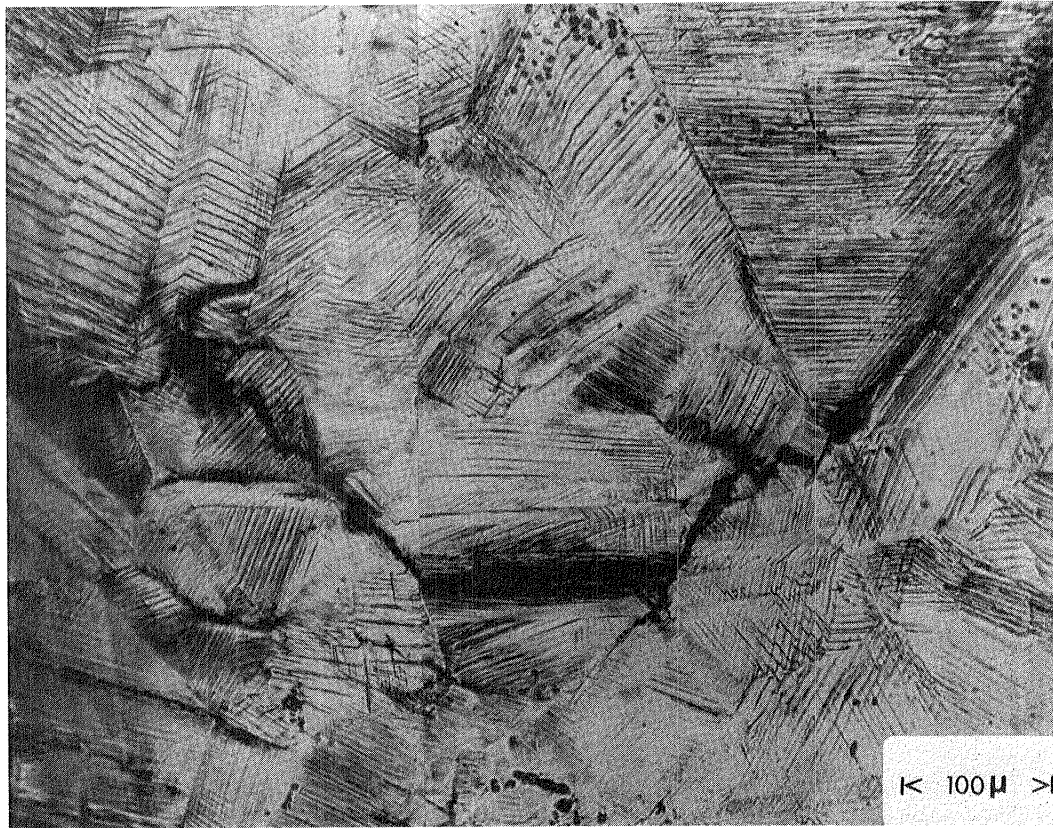
Figure 49 Slip band cracking in the coarse grained small γ' specimen N_1 3 ($\Delta\epsilon_p = 3.00\%$) after 640 cycles (90% of the total life). Crack length was $\sim 500 \mu$.

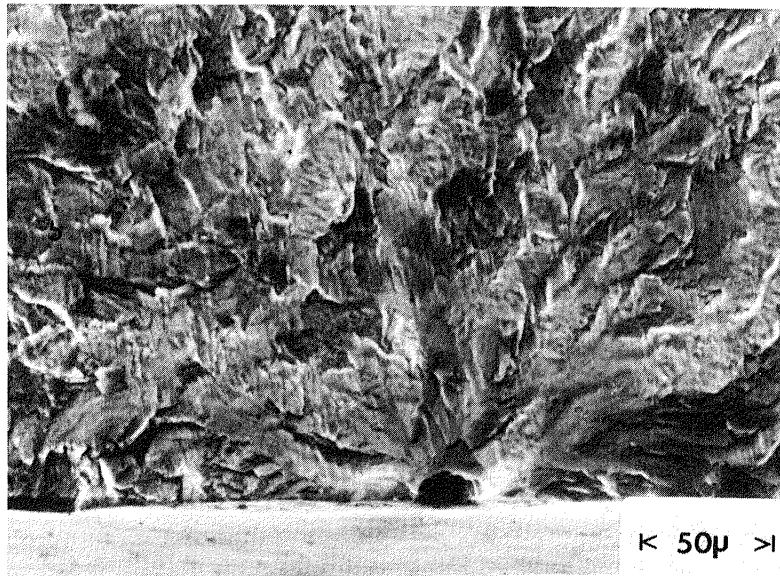
Figure 52 Fine grained large γ' specimen 21, tested at 500 C.
a) Transgranular initiation. b) Propagation by a striated mechanism. Arrows indicate secondary cracking forming along the striations.
